MAXI GSC calibration for 10 years data

Mutsumi Sugizaki (Tokyo Institute of Technology)
on behalf of MAXI Team

MAXI (Monitor of All-sky X-ray Image) on ISS

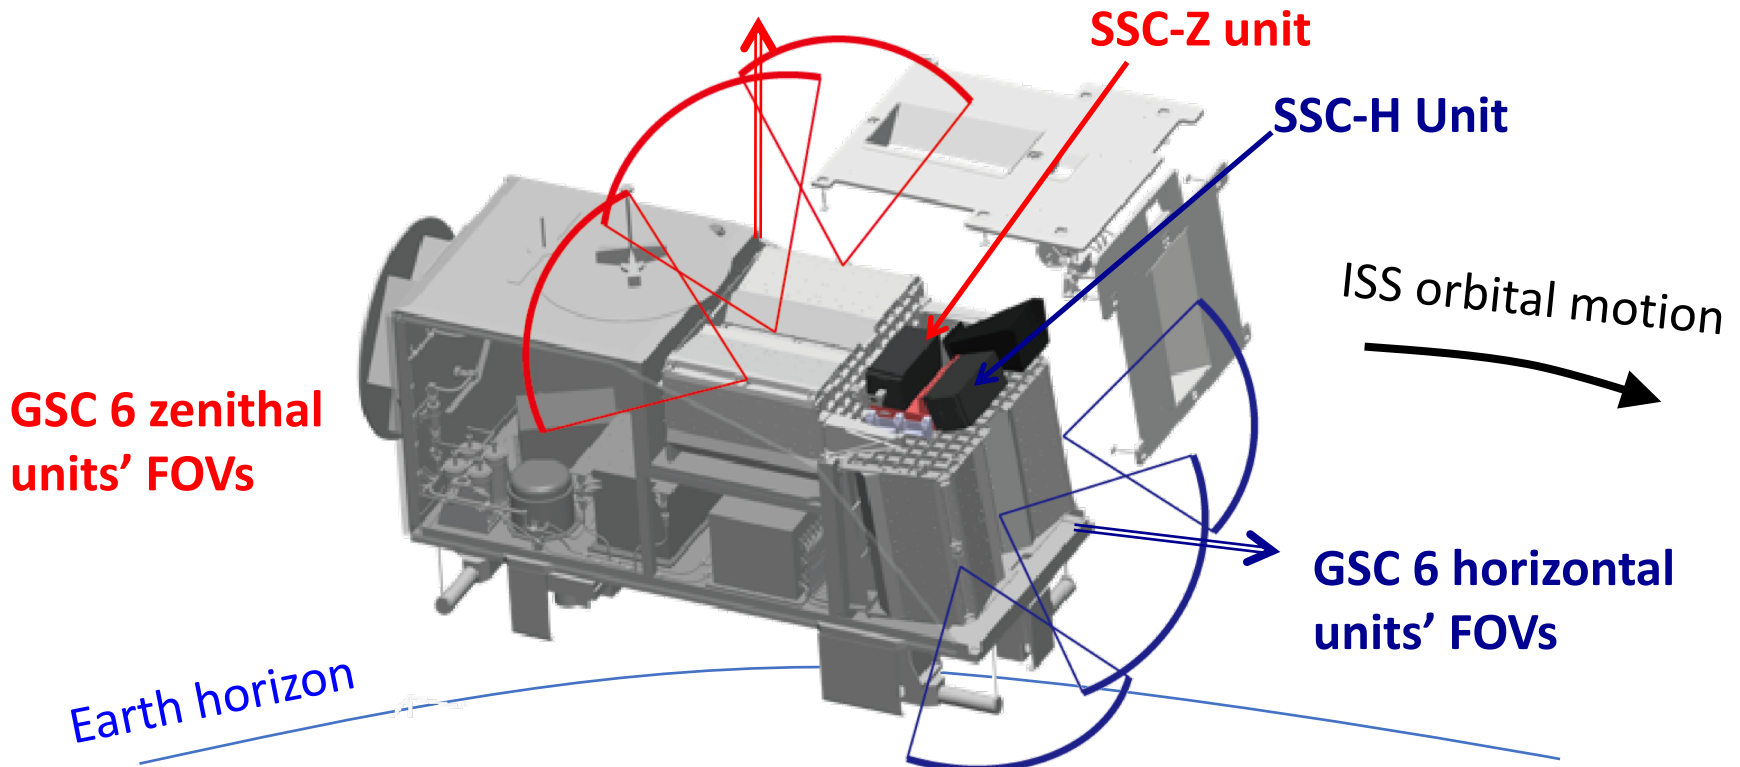
- **GSC (Gas Slit Camera)** 2-30 keV band **Large area**
 - 1-D position-sensitive Xe-gas counters and slit collimators with slit
 - Anti-coincidence BGD rejection (e.g. Ginga/LAC, RXTE/PCA, ASM)
 - 12 identical units to cover 1-D horizontal and zenithal FOVs.
- **SSC (Solid-State Slit Camera)** 0.5-12 keV band **Good energy resolution**
X-ray CCDs + Slat Collimator and Slit

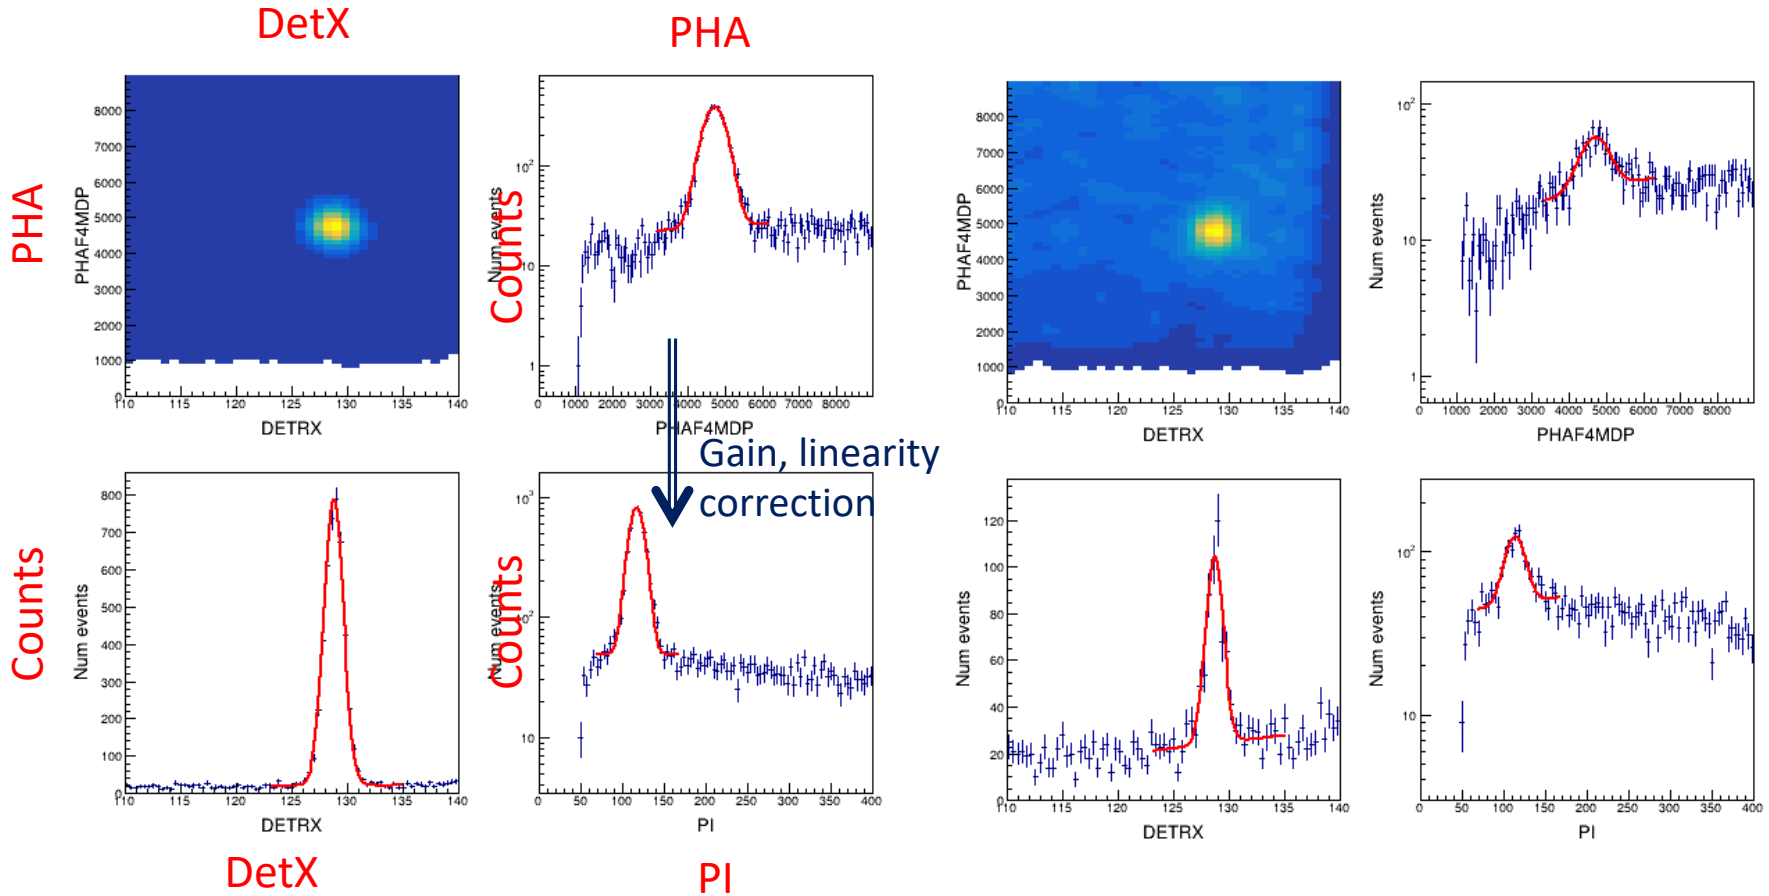
Gain & efficiency monitor with ^{55}Fe 5.9 keV cal. source

2009-08-14 $\xrightarrow{9 \text{ years}}$ 2018-11-15

$$0.5^{\left(\frac{9.25 \text{ yr}}{2.73 \text{ yr}}\right)} = 0.09$$

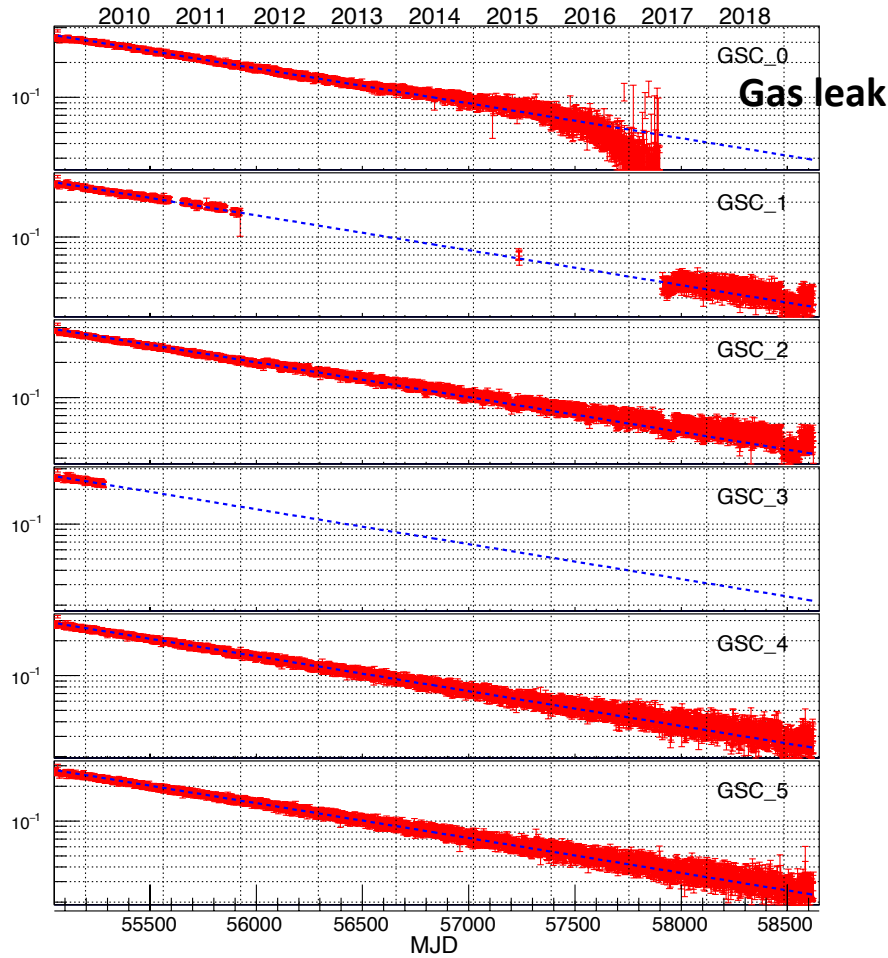
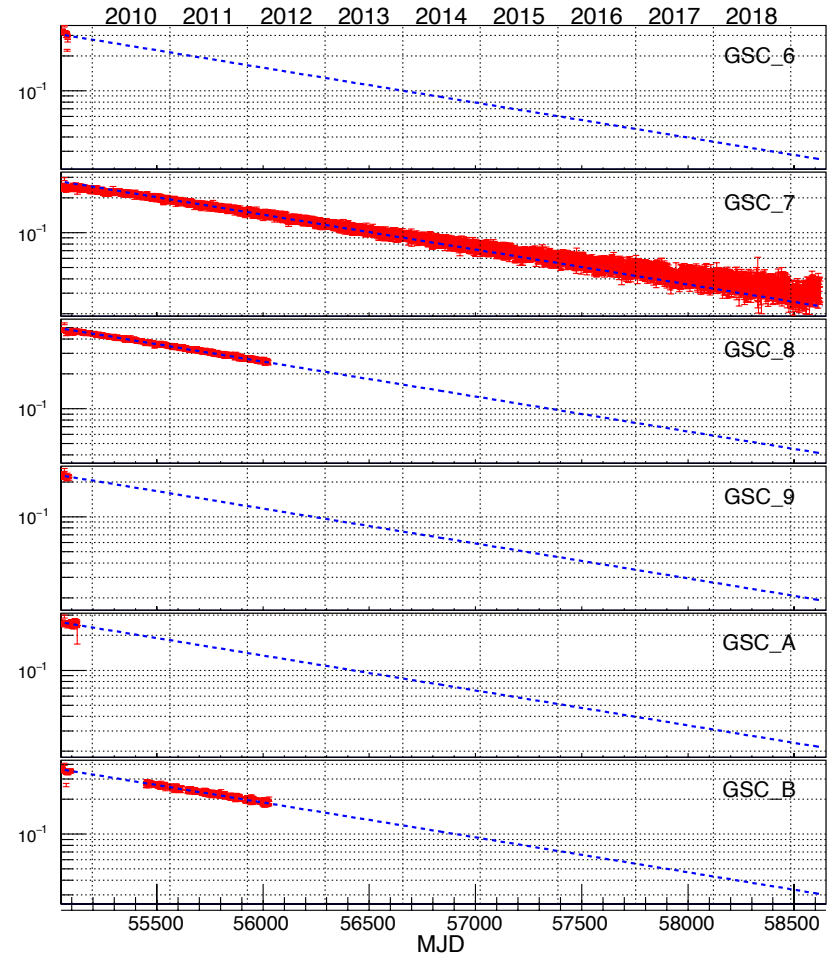
^{55}Fe 5.9 keV cal. source rate (efficiency)

$T_{1/2} = 2.73\text{ year}$

Except for GSC_0, the Iron-55 rate agree with that expected from $T_{1/2} = 2.73\text{ yr}$.

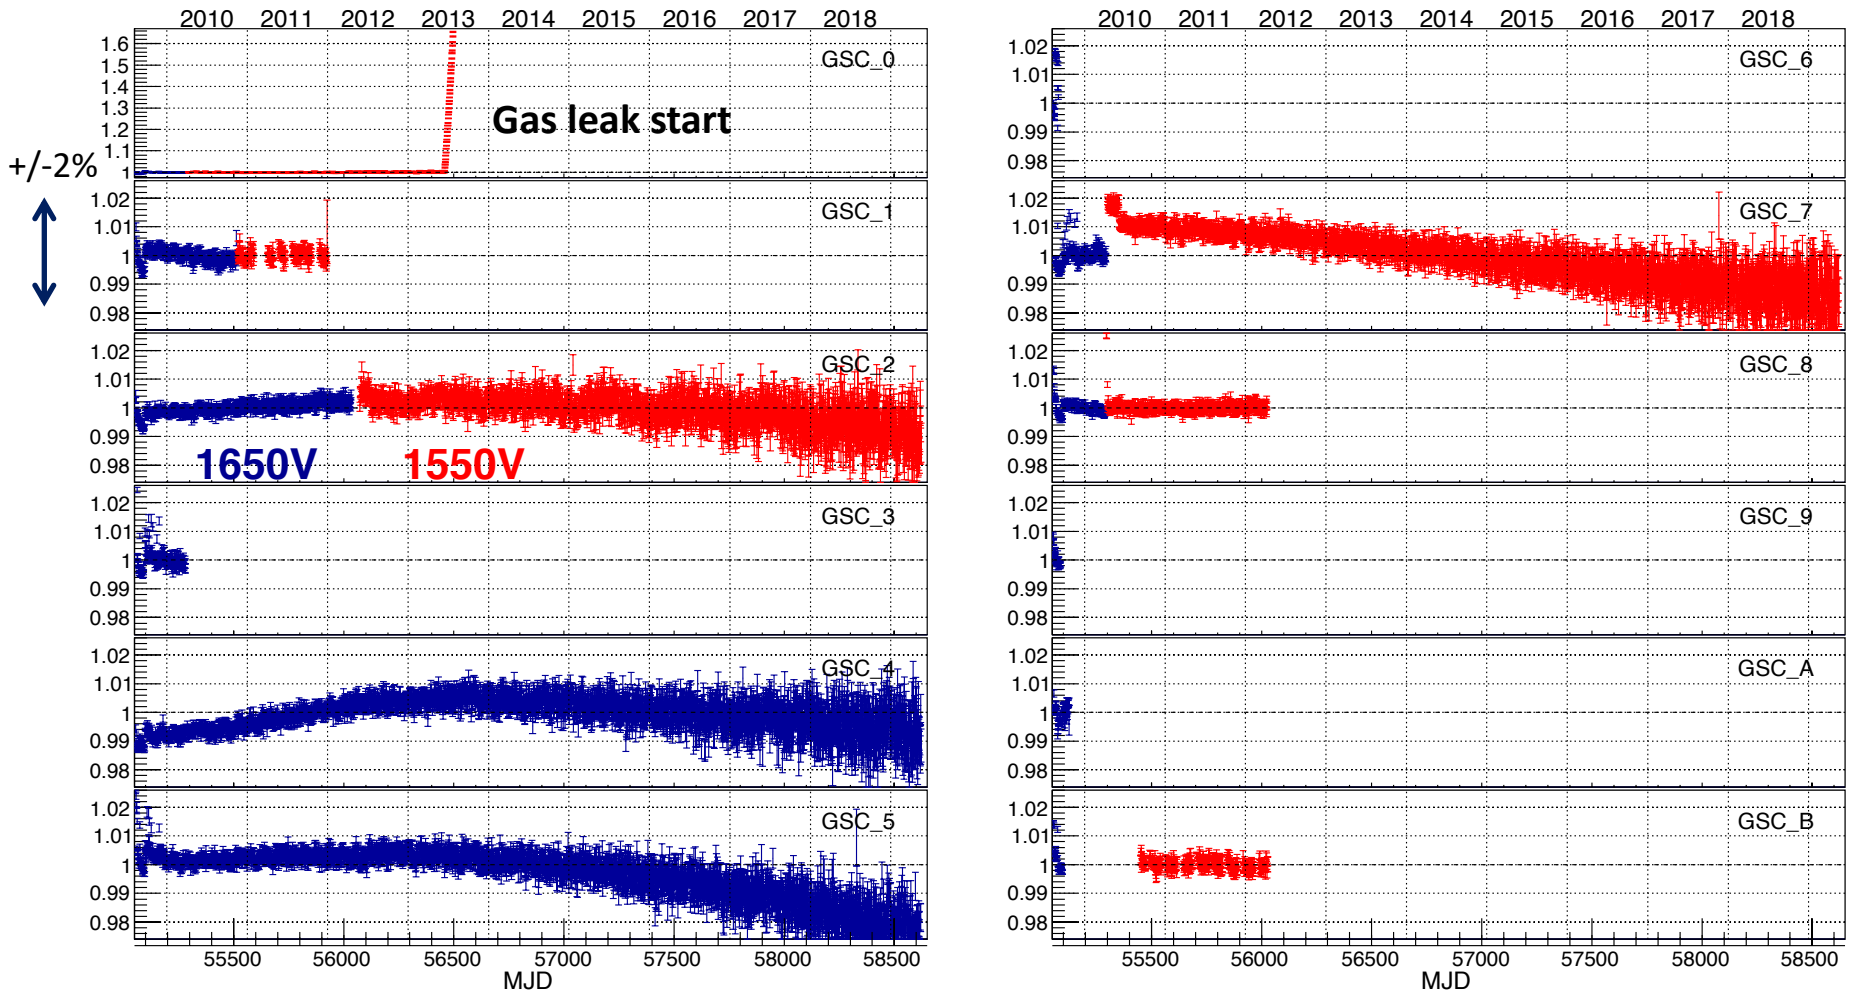
Gain stability (PHA for 5.9 keV X-ray)

Except for GSC_0, the gas-amplifier gain is stable within 2 %.

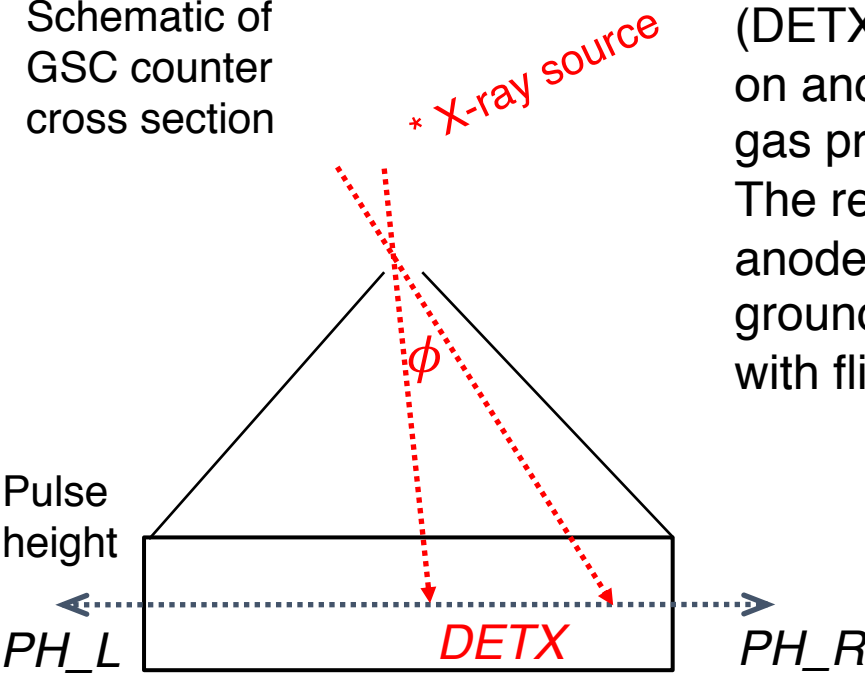
Schematic of GSC counter cross section

Resistive anode length = l

$PH_L =$ Pulse height L $\propto l / (l - DETX)$

$PH_R =$ Pulse height R $\propto l / DETX$

$$DETX = f \left(\frac{PH_R - PH_L}{PH_R + PH_L} \right)$$

GSC detector position (DETX) response depends on anode resistance, HV, gas pressure.

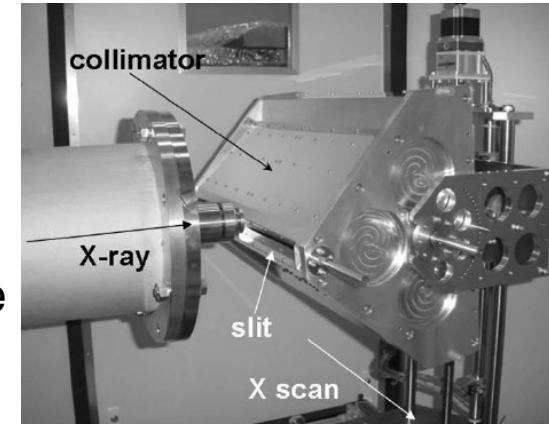
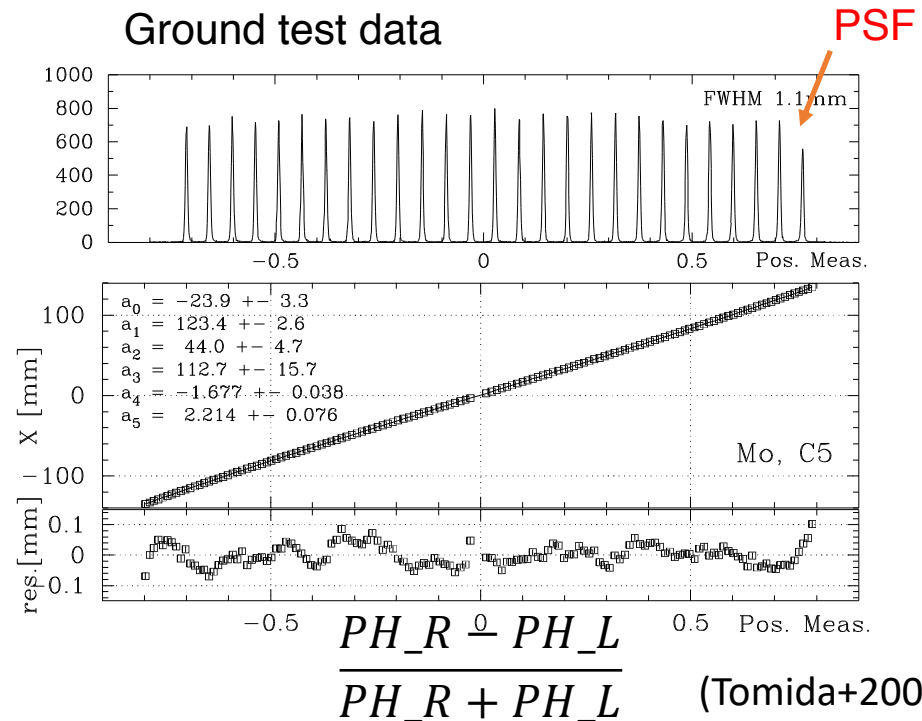
Ground test data

The response of $12 \times 6 = 96$ anodes are measured in the ground test, and calibrated with flight data.

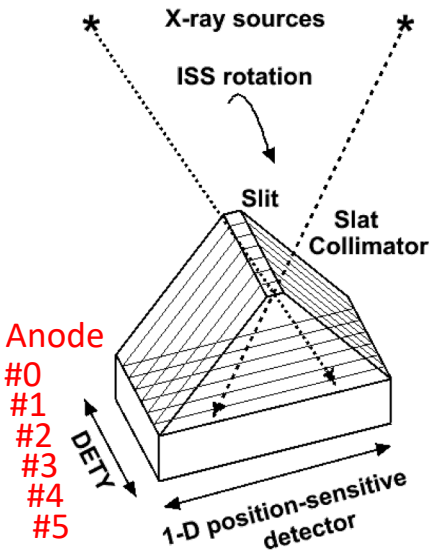
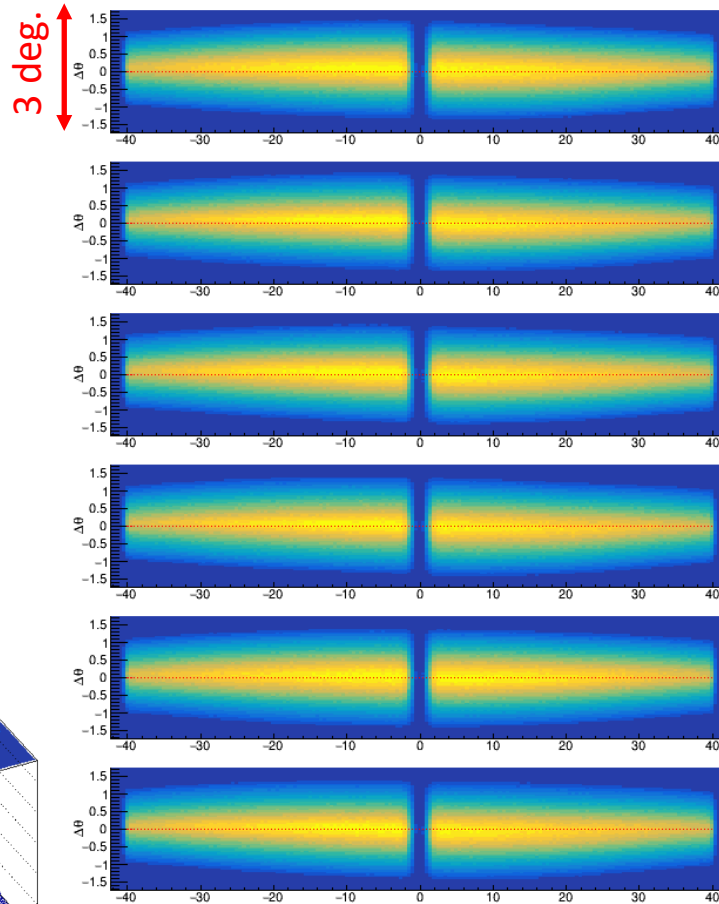
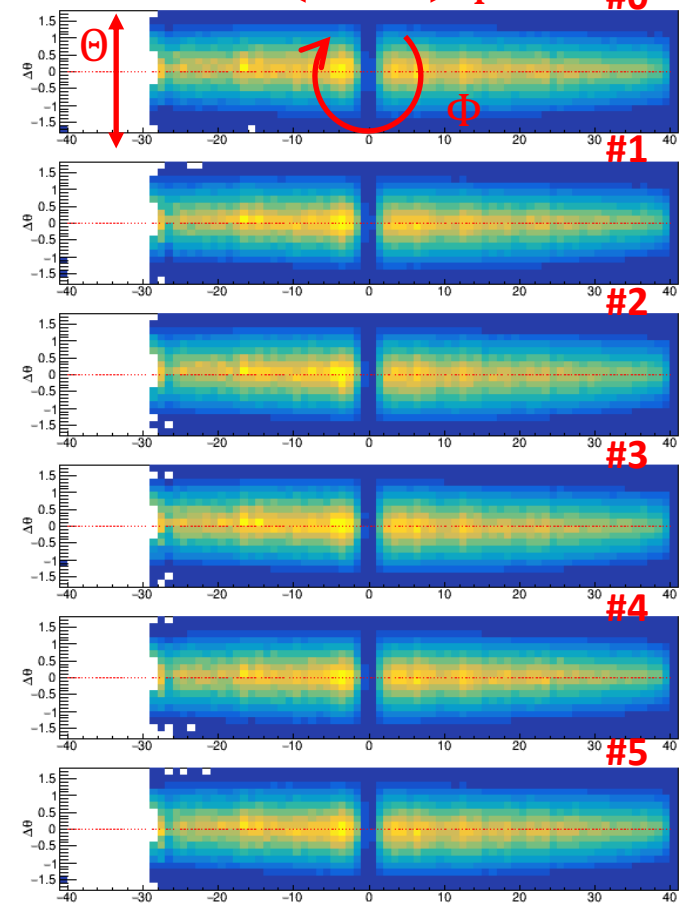
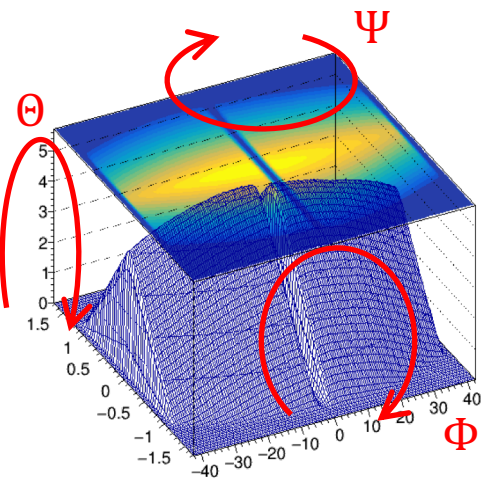
In-orbit position-response calibration

Ground calibration (CALDB)

Data for Sco X-1

- Fit to refine alignment parameters Θ , Φ , Ψ , and PHA ratio-DETX relation
- Source localization accuracy became ~ 0.1 deg.

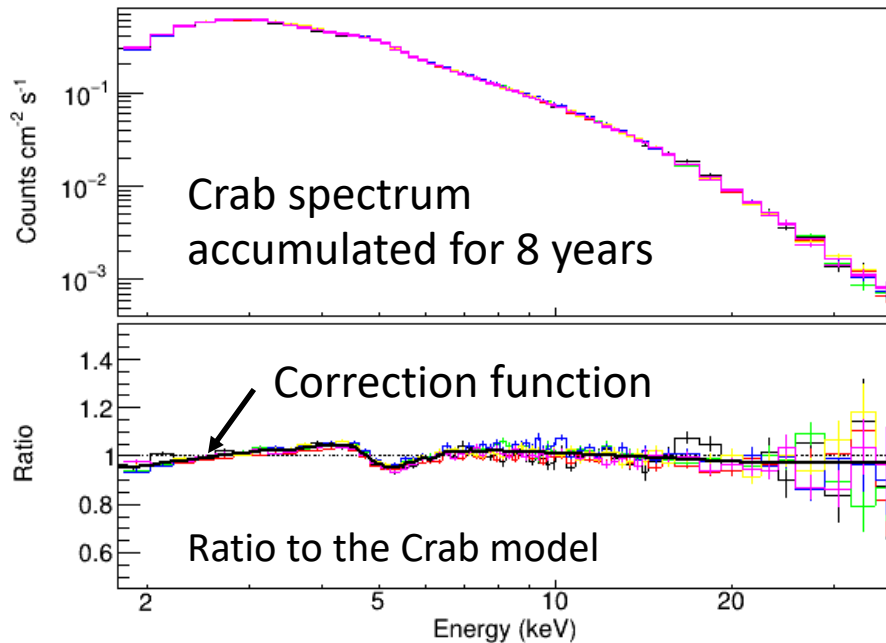
GSC_4: HV=1650V

- Correction from the ground RMF measured at HV=1650V

As for good GSC units, the average RMF is calibrated in a precision of 1-2 %.

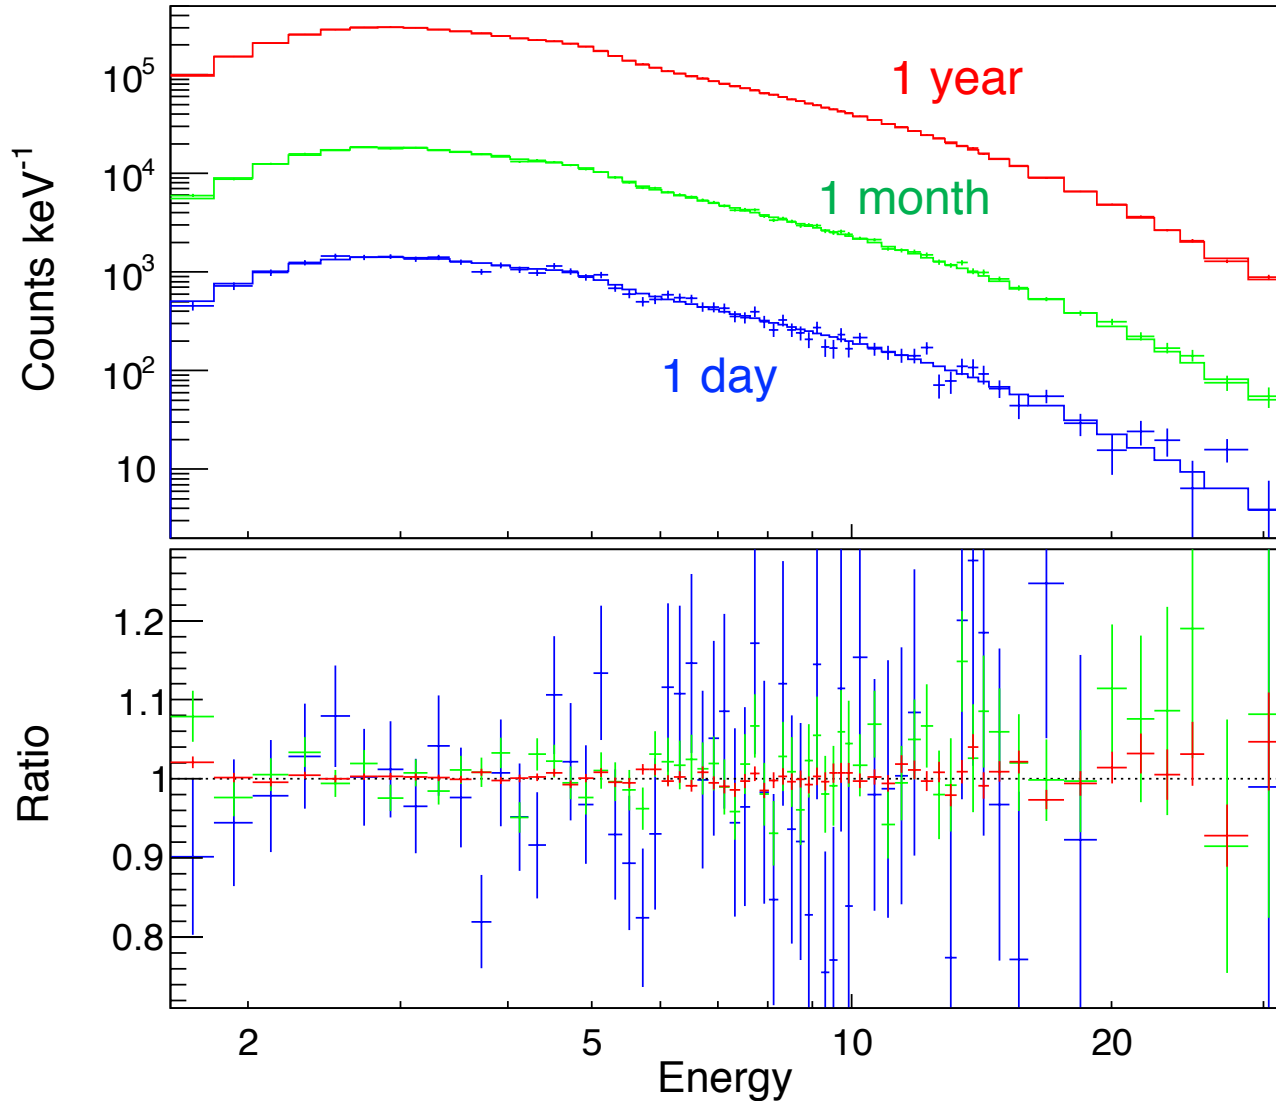
1-day 1-month 1year Crab spectrum

1-year Crab data reaches ~1% statistical precision.

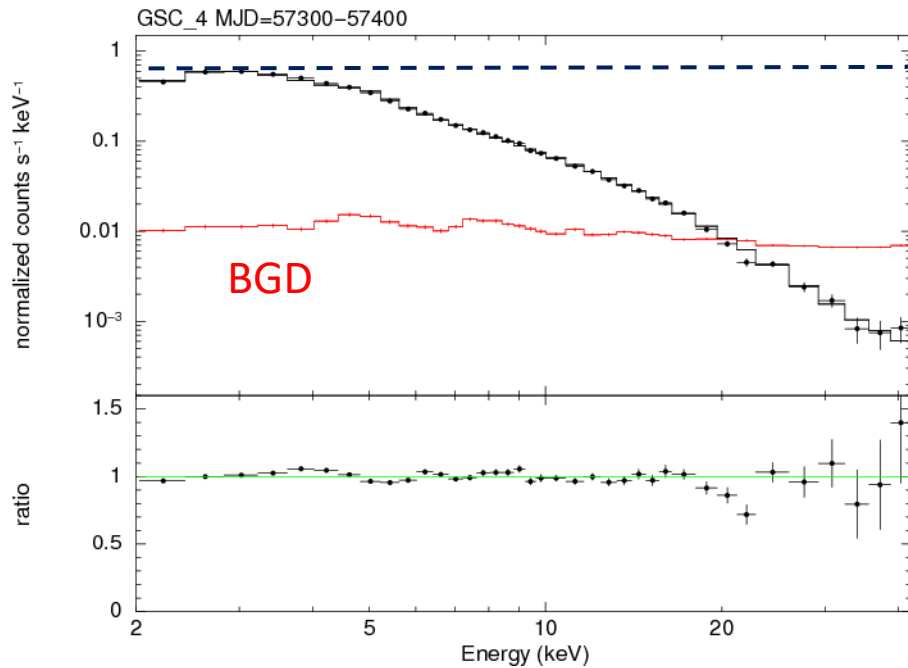
GSC 4: normal detector

Response of GSCs with a fractured anode (GSC_3, 6)

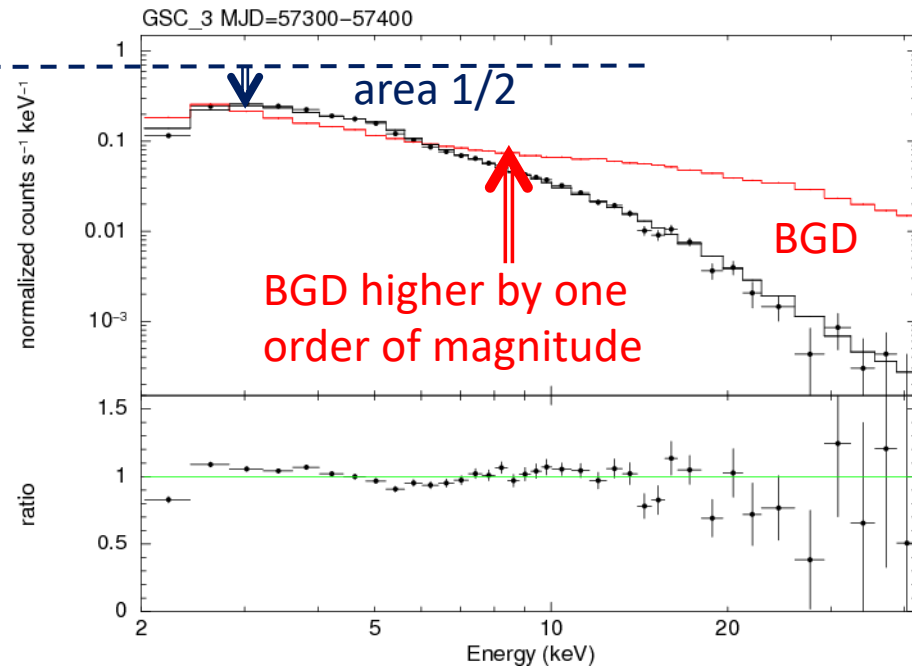
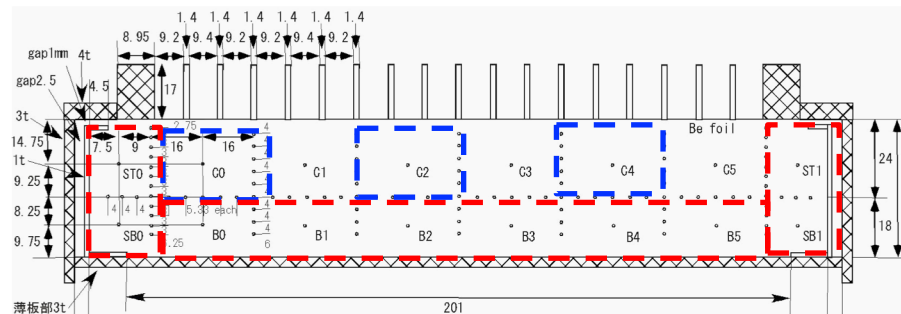
GSC 3: half area, no veto

Alive anode cells

Malfunctional cells

Gas counter cross section

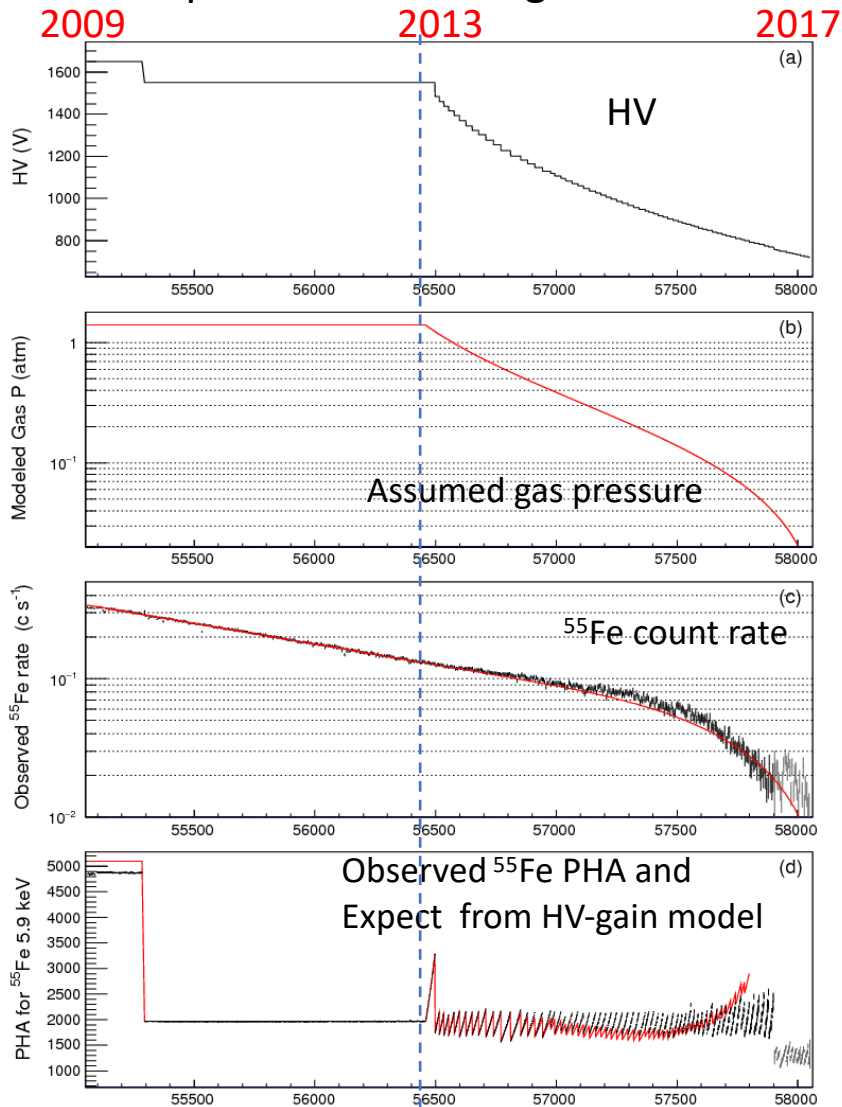
Gas pressure modeling

Response of GSC_0 after gas leak
